# Canon Business Ink Jet Printer Ink Performance Comparison Test TEST REPORT

Release Date: 08/27/2020

## Canon Business Inkjet Printer Ink Comparison Test

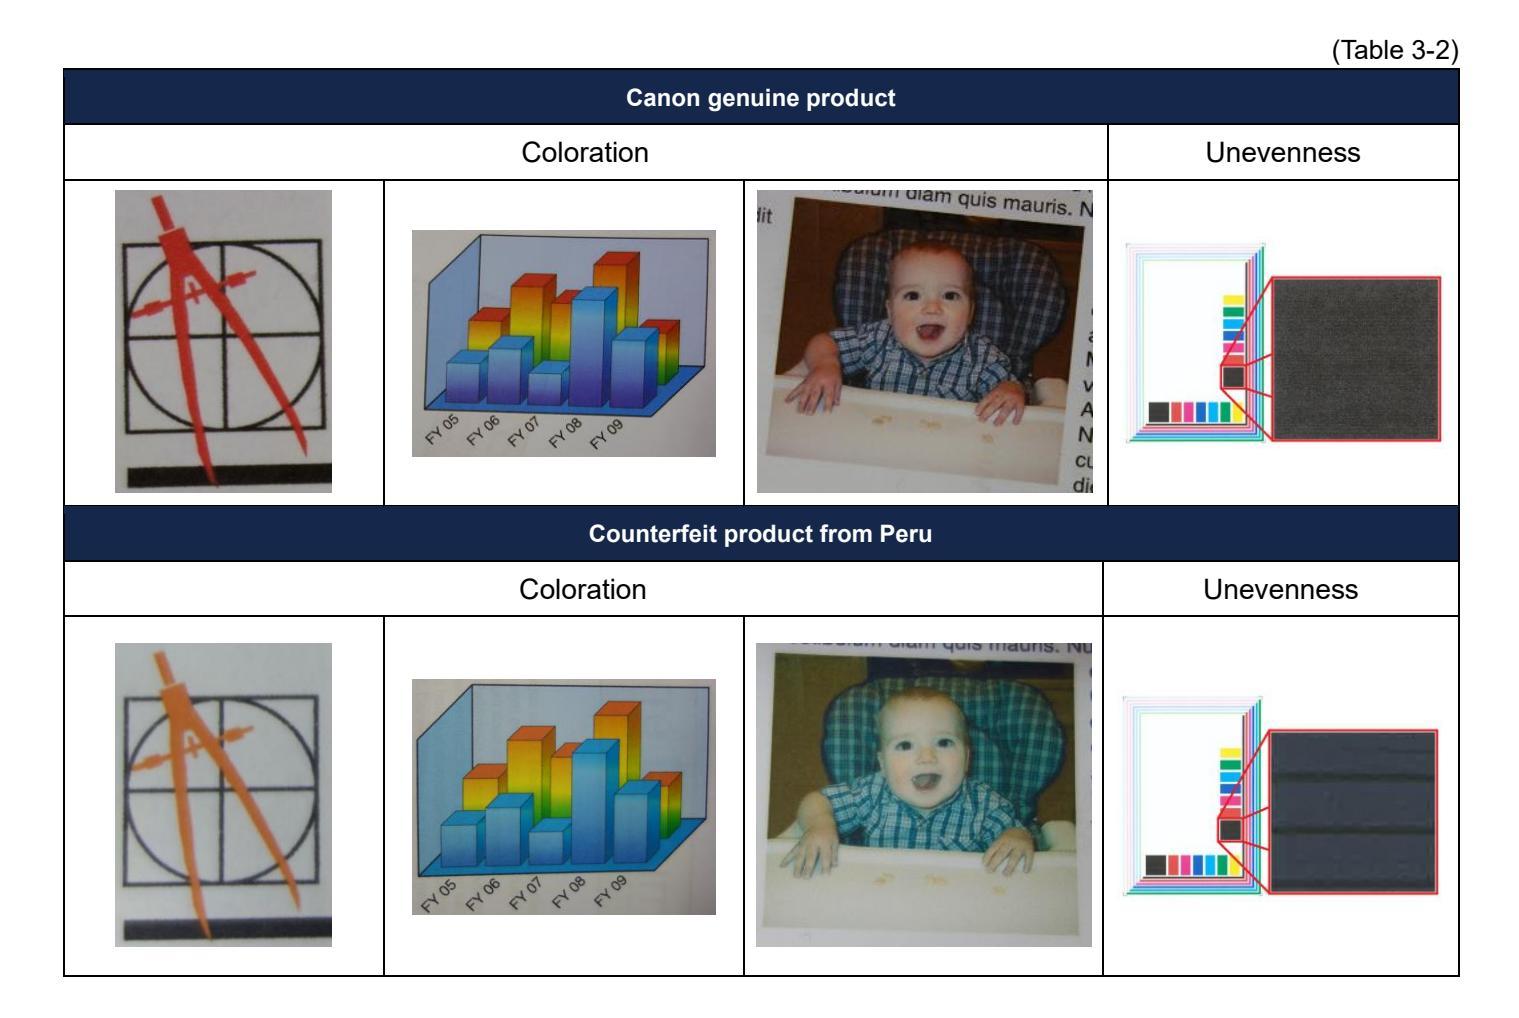
- As for the counterfeit product from Peru, the color of the magenta was lighter and brighter than that of the Canon genuine products, and when compared to the Canon genuine product, the color did not appear to be printing normally. (Table 3-2)
- As for the counterfeit product from Peru, unevenness was identified in places where there were large printed areas of black. (Table 3-2)

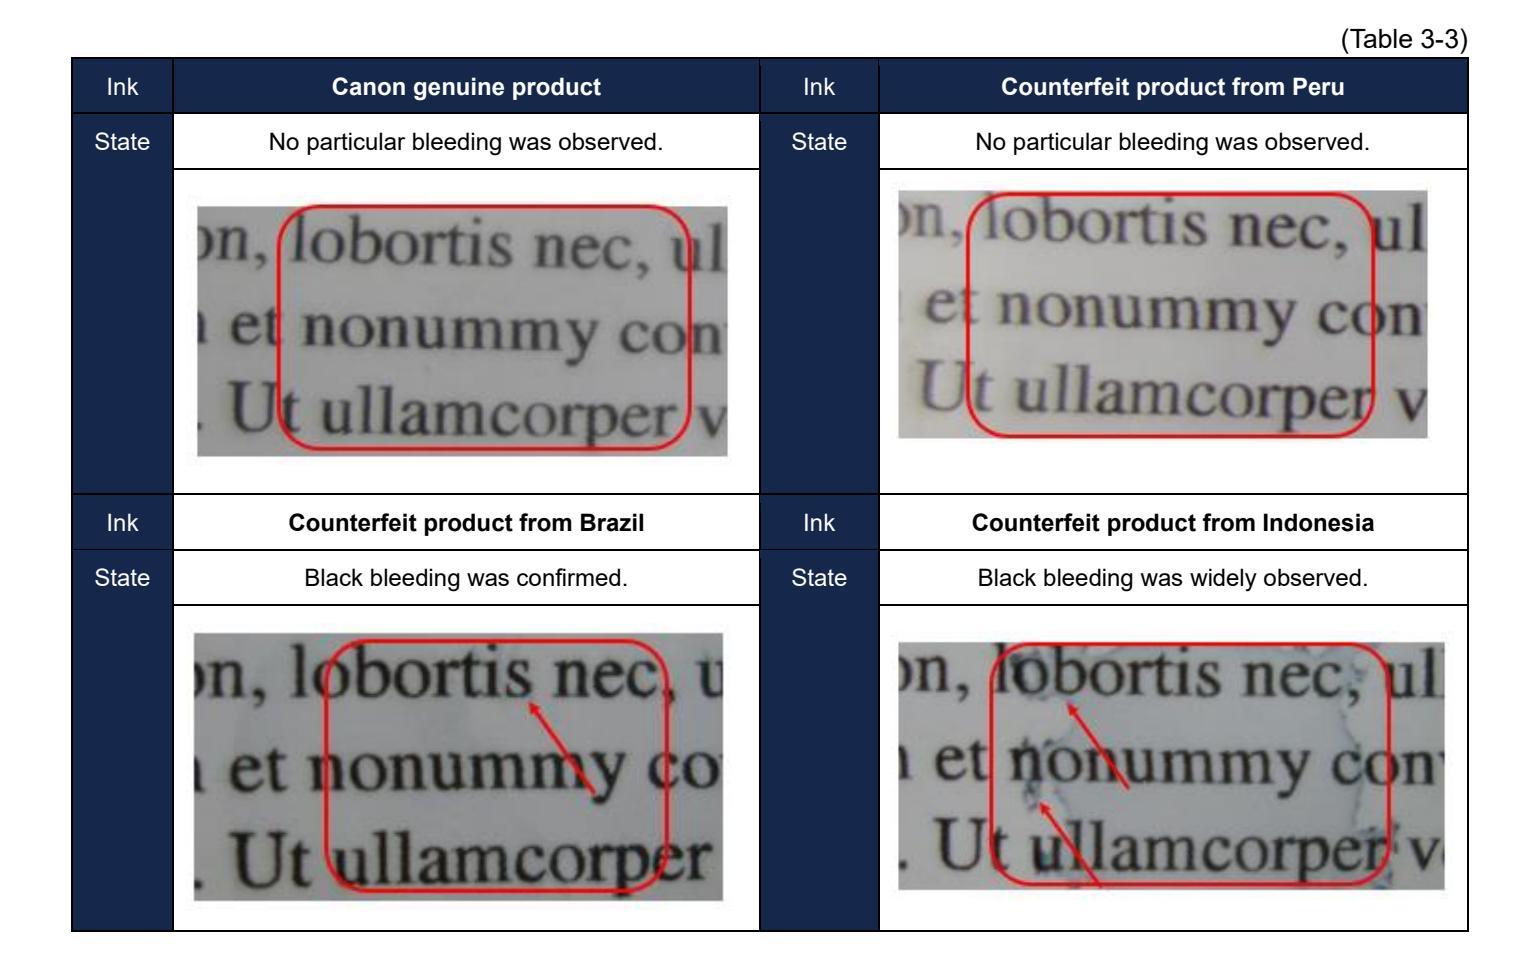
• As a result, the phenomenon of the black dissolving into water was confirmed in the counterfeit product from Brazil and in the counterfeit product from Indonesia. (Table 3-3)
